# **Mir Photo/TV Survey (DTO-1118): STS-86 Mission Report**

Prepared by:  
**Image Science and Analysis Group**  
**Space Science Branch**  
**Earth Science and Solar System Exploration Division**

March 4, 1998

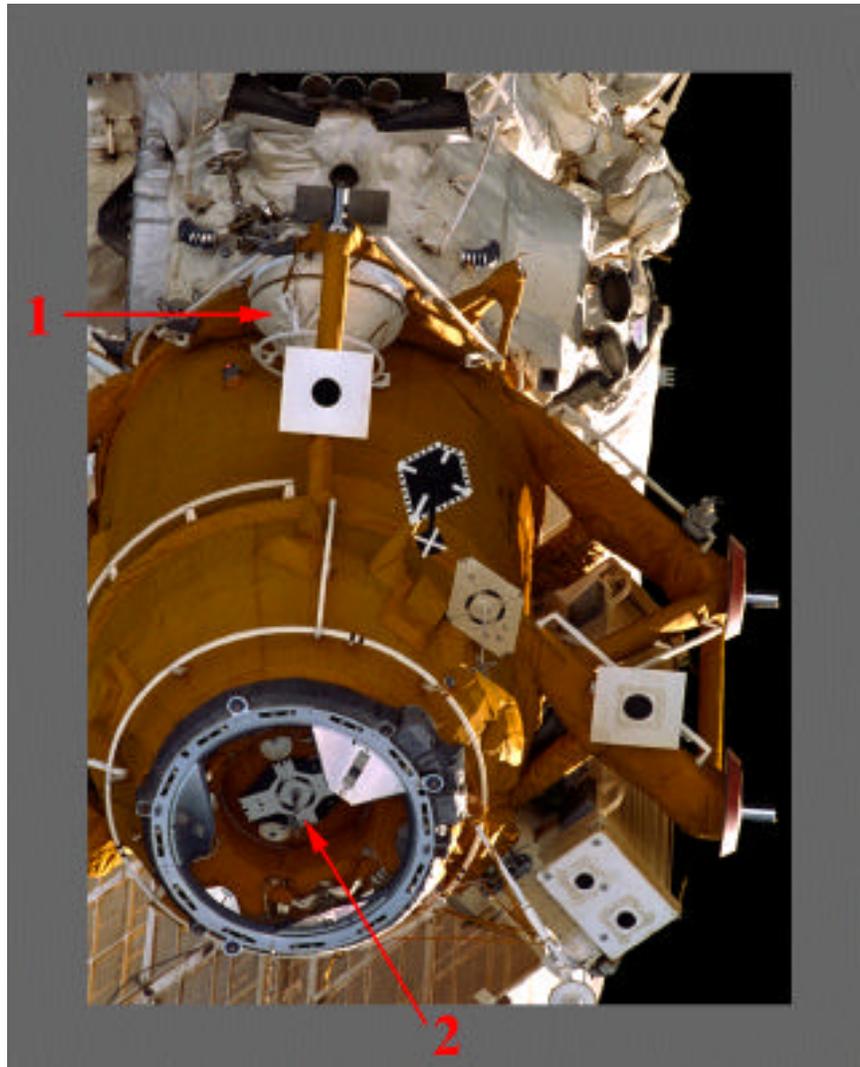
**Figure 2.2 -XB Backaway Overview of the Docking Module**

Figure 2.1 provides an overview of the Mir modules in their STS-86 configuration. The backaway image of the Docking Module in Figure 2.2 identifies the Spektr SP#1 sealant cover, which was attached to the Docking Module during an EVA from the Shuttle, and the new Centerline Docking Target attached to the Docking Module hatch prior to undocking. The fly-around view in Figure 2.3 shows an unidentified feature on Spektr which has not been visible in previous mission photography. Figures 2.4 - 2.7 show fly-around photography which provides the highest resolution views to date of several modules.

- 1. Sealant Cover for Spektr SP#1 Mount\***
- 2. New Centerline Docking Target**

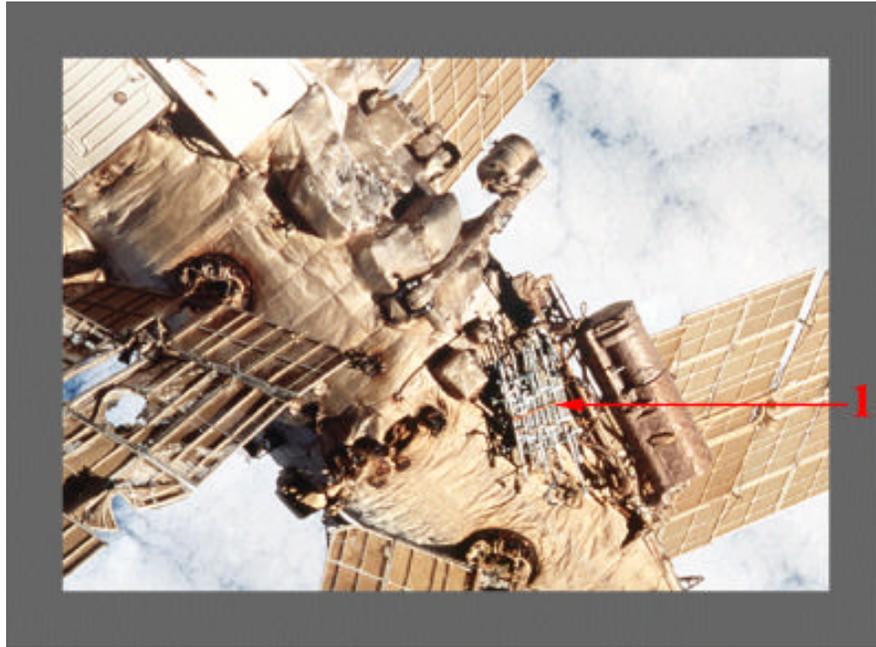
**Figure 2.3 +XB, +ZB Fly-around Overview of Spektr**

**1. Unknown\***

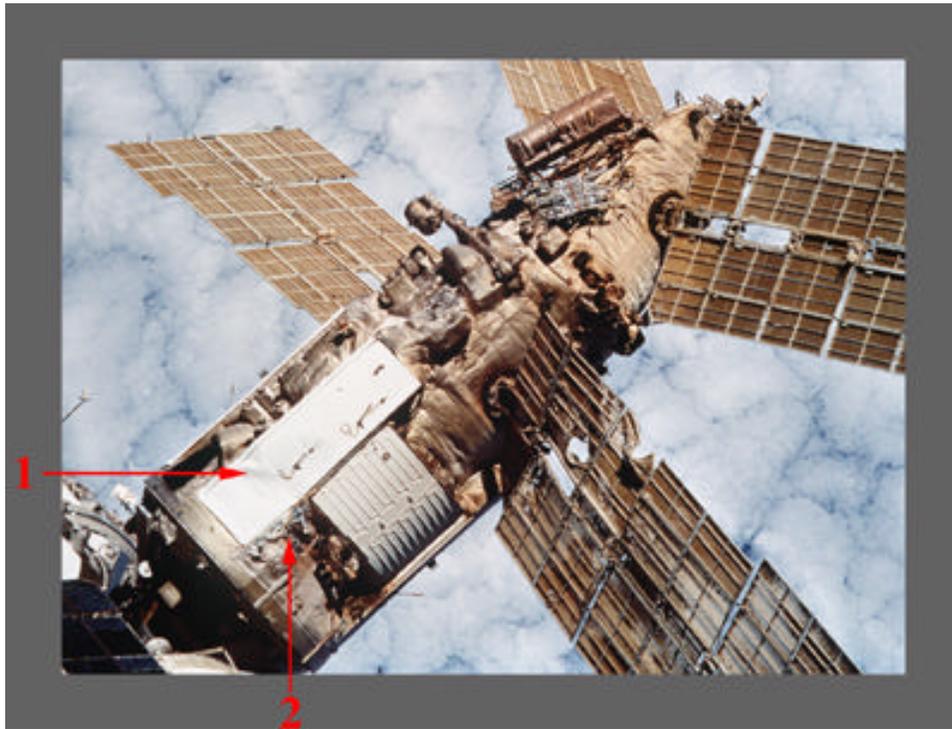
**Figure 3.1 +XB, +ZB Overview of Spektr Module Damage**

Figure 3.1 is an overview photograph which shows the damage sustained to the surface of the Spektr module. This photograph provides a face-on view of the damage to the +XB, +ZB radiator [1]. The photograph also shows the thermal insulation [2] that was cut so that a camera could be inserted under the radiator in an attempt to find the source of the leak in the module.

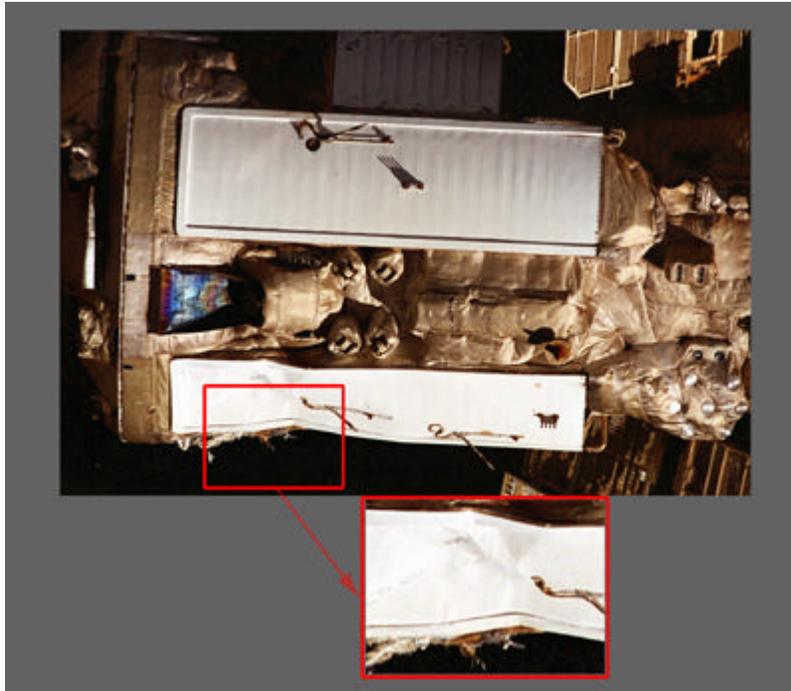
**Figure 3.2 +XB, +ZB Spektr Radiator Damage**

Progress contacted the surface appears to have a wide scrape [1]. There also appears to be a long, narrow shadow cast by a possible piece of thermal insulation [2]. There are several pieces of apparent thermal insulation which are probably residues of the EVA thermal insulation cutting activity performed to look for leaks in the surface of Spektr under the bent radiator. The results of this EVA activity are highlighted in Figure 3.4.

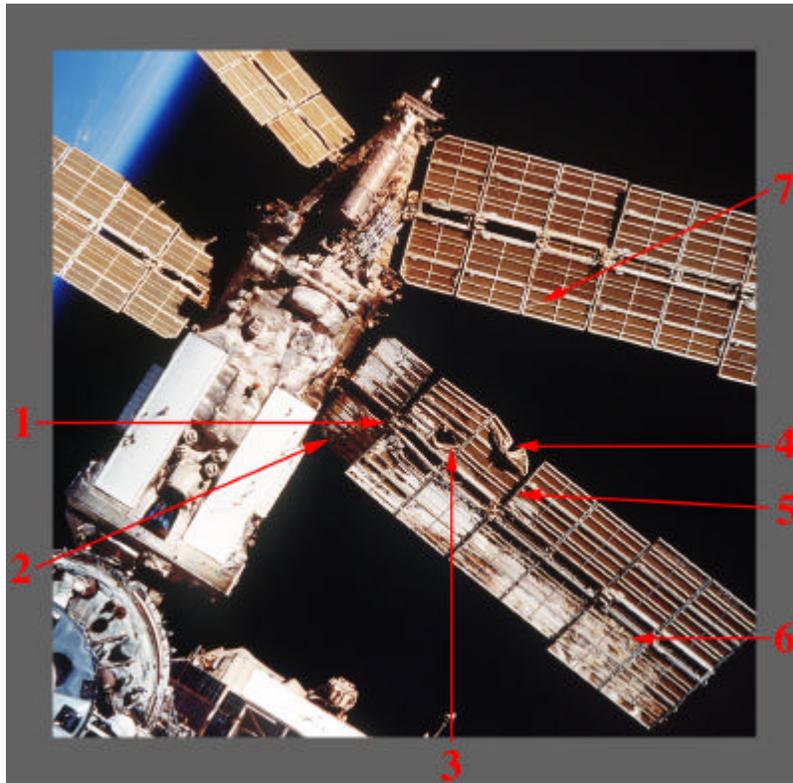
**Figure 3.5 +XB View of the Back Side of Spektr SP#1 and SP#3 Solar Array Damage**

Figure 3.5 is an overview photograph which shows the back-side of all solar array surfaces which were damaged during the Progress collision. Damaged areas of SP#1 are indicated by Items 1-6, and damage to SP#3 is indicated by Item 7. One of the two separate support beams which make up SP#1's central support structure has sheared next to what appears to be a weld joint [1]. The other beam also appears to have sheared, but the sheared ends appear to remain in contact with each other. Dividing each array into seven major sub-panels, these sheared center beams are located just above the break between the first and second sub-panels from the array's attach point on Spektr. The first sub-panel has a bent corner [2], and there is a large hole through the second sub-panel measured to be 0.25 m<sup>2</sup> in area [3]. An upper corner of the third sub-panel is severely bent [4], the lower edge of the fourth sub-panel is bent [5], and one of the supports in the seventh is broken and bent out of the frame [6]. On SP#3, a support in the third sub-panel is bent, and there appears to be a scrape mark on the back side of the solar panel adjacent to this support [7].

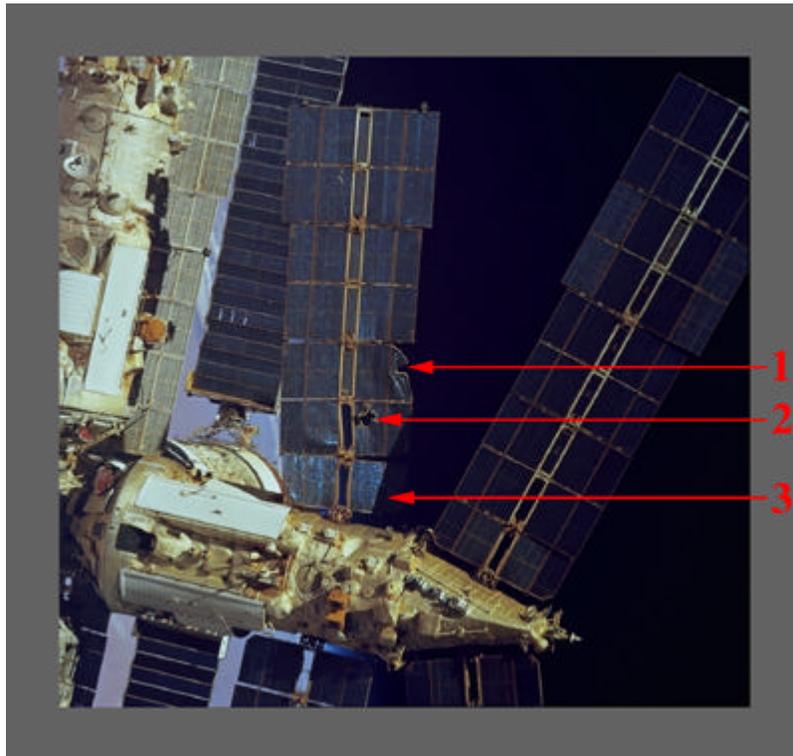
**Figure 3.6 -XB View of the Front Side of Spektr SP#1 and SP#3  
Solar Array Damage**

Figure 3.6 shows a photograph taken during the fly-around of Mir by Soyuz. This view shows the front surface of the Spektr arrays. The severe bend in the upper corner of the third sub-panel [1] and the large hole through the second sub-panel [2] can be seen in this photograph. Note that the edge of SP#3 is shadowing the lower corner of SP#1 [3].

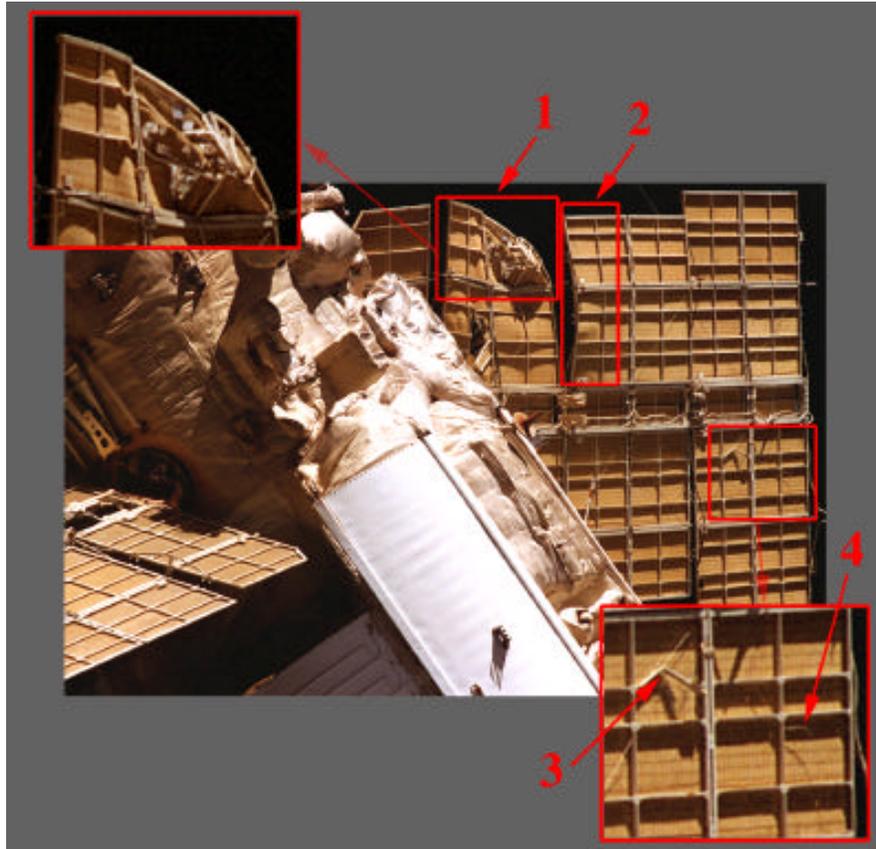
**Figure 3.7 -ZB Overview of Spektr SP#1 Damage**

Figure 3.7 is a photograph of Spektr SP#1, taken from the -ZB perspective, which shows the back-side of the array. The highlighted region at the top of the figure provides a magnified view of an upper corner of the third sub-panel, which is severely bent [1]. The lower edge of the fourth sub-panel is bent [2]. The magnified view at the bottom of the figure shows the damage on the seventh and eighth sub-panels. One of the supports in the seventh sub-panel is broken and bent out of the frame [3]. A support wire running across the back of the eighth sub-panel is loose, suggesting it snapped in the collision [4].

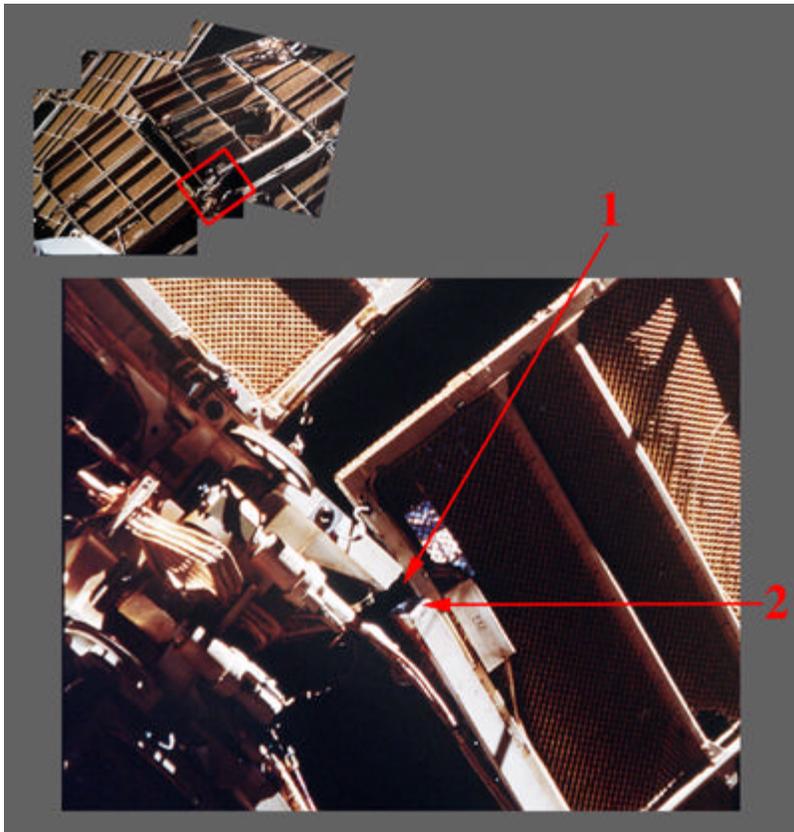
**Figure 3.8 Close-up of Spektr SP#1 Sheared Support Beam**

Figure 3.8 is a close-up photograph of the damage to SP#1's central support structure. One of the two beams has sheared and separated completely [1]. The beam has a clean break along what appears to be a weld joint [2]. The beam along the other side of the central support structure is in shadow in this photograph. Figure 3.9 shows the damage to the support beam adjacent to the beam described in Figure 3.8. In the photograph on the left, the upper section of the beam [1] above the sheared region appears to be pushed back and to the left of the lower section of the beam [2] adjacent to the array attach. The image on the right provides a view of the other side of the array and supports the description of the damage from the image on the left. As expected, the upper portion of the beam [3] appears to be to the left and extending further toward the image plane than the lower portion of the beam [4]. Based on these two observations, the upper and lower sections of the beam appear to be in contact even though the beam appears sheared.

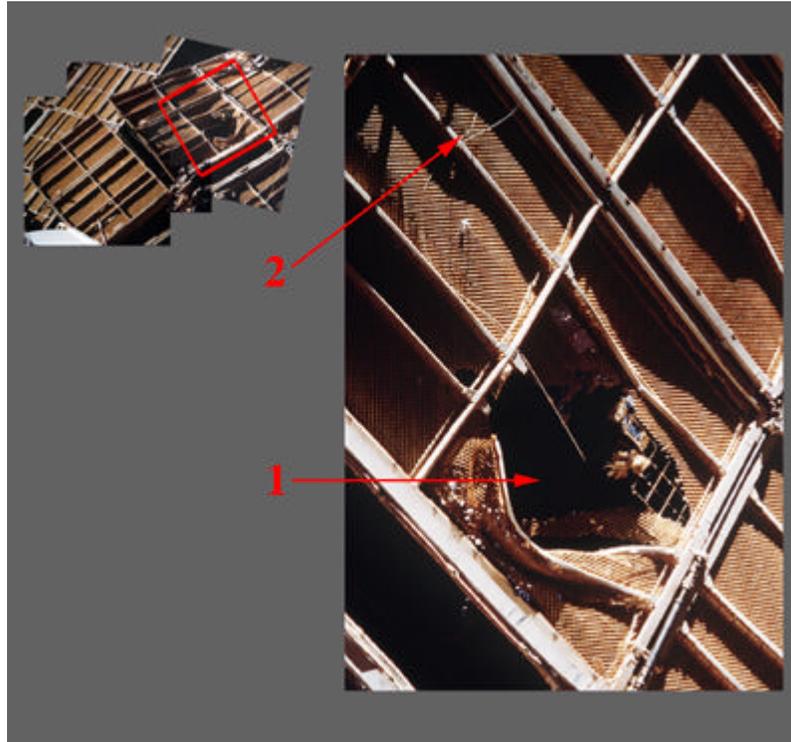
**Figure 3.10 Close-up of Hole in Spektr SP#1**

Figure 3.10 is a close-up photograph of the hole in SP#1's second sub-panel [1]. The hole area was measured to be approximately 0.25 m<sup>2</sup>. A support wire [2] running across the back of the sub-panel is also broken. There appears to be support wires running diagonally across the back of all sub-panels.

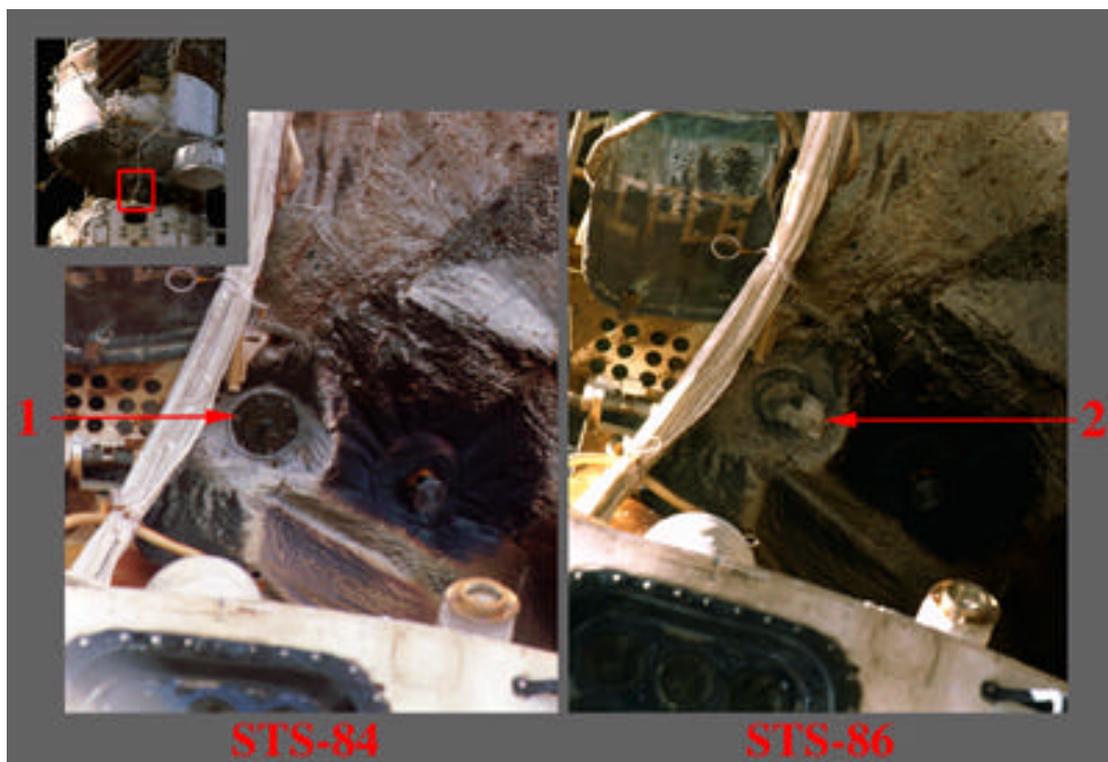
**Figure 3.11 Substance on end of Kvant End Dome Purge Port**

- An unknown substance is covering a purge port on the Kvant end dome. This port has appeared free of contaminants on previous mission photography. Section 3 provides an assessment of the condition of Kvant surfaces from the detailed photography acquired of the module on STS-86.

Figure 3.11 is a comparison of photographs between STS-84 and STS-86 of the purge ports located on the Kvant end dome adjacent to the Base Block. The photograph on the left shows one of the purge ports [1] to be free of any contaminants. This port has appeared free of contaminants on previous missions where it was visible (STS-79 and STS-81). The photograph on the right reveals a white substance which covers this same purge port [2], and there appears to be spots of a similar substance on some surfaces adjacent to the port.

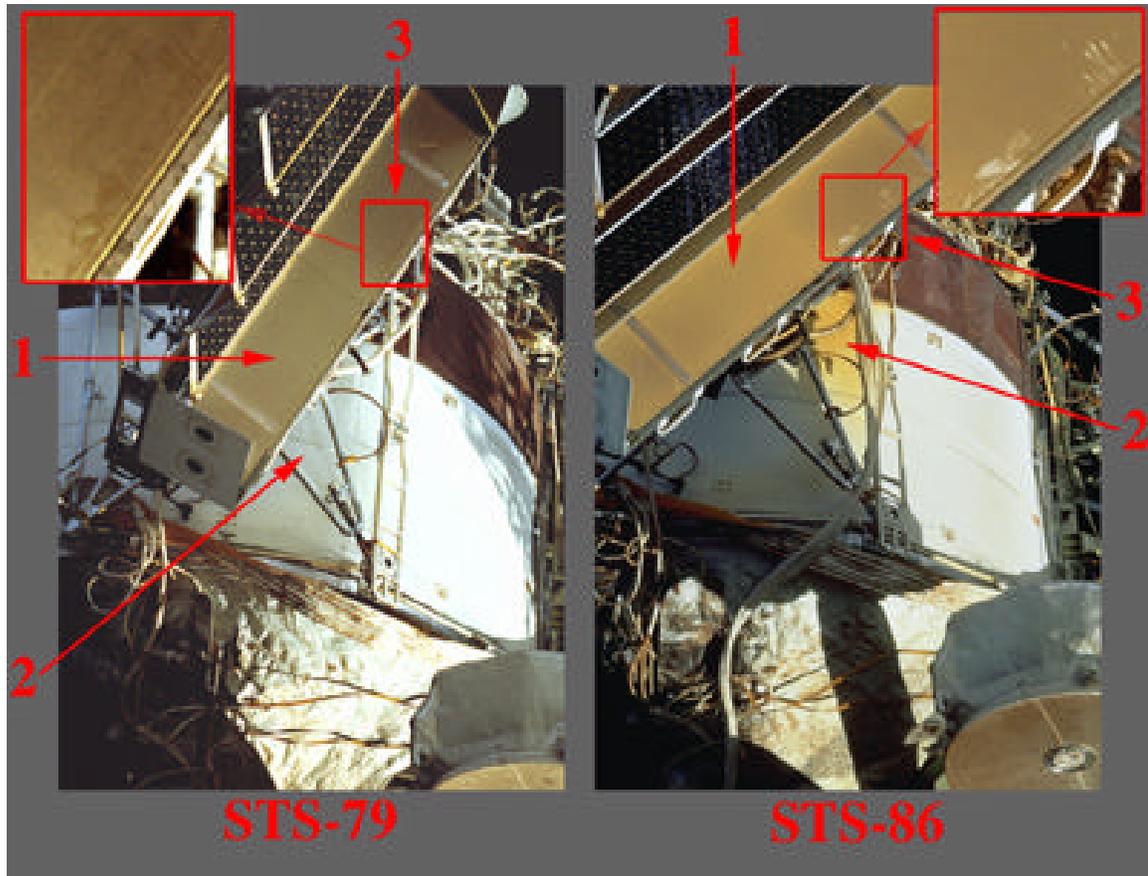
**Figure 3.12 Deposition on -ZB Kvant Radiator Surface**

Figure 3.12 is a comparison of photographs between STS-79 and STS-86 which show the attach region of the CSA. The CSA was deployed on the Kvant -ZB axis on May 25, 1996. The photograph on the left was taken in late September 1996 (during STS-79). The CSA carrier [1] and the Kvant radiator surface [2] appear to be free of discoloration in this photograph. However, the photograph on the right, taken 16 months later on STS-86, shows apparent discoloration on both the CSA carrier [1] and Kvant radiator surface [2] which appears brown in color, and may be caused by a contaminant deposited on the

surface. There also appears to be a preferential pattern to this deposition on the radiator surface. The heaviest deposition appears to be occurring in the +XB, +YB direction away from the CSA attach point. However, the extent of the pattern cannot be identified since the array is obstructing much of the view of the surface of the Kvant radiator. There are some thin lines of brown discoloration on the CSA carrier in the photograph taken during STS-79 [3]. These same lines appear white in the photograph taken during STS-86 [3]. Except for this feature [3], the rest of the carrier is darker and appears to have additional deposition.

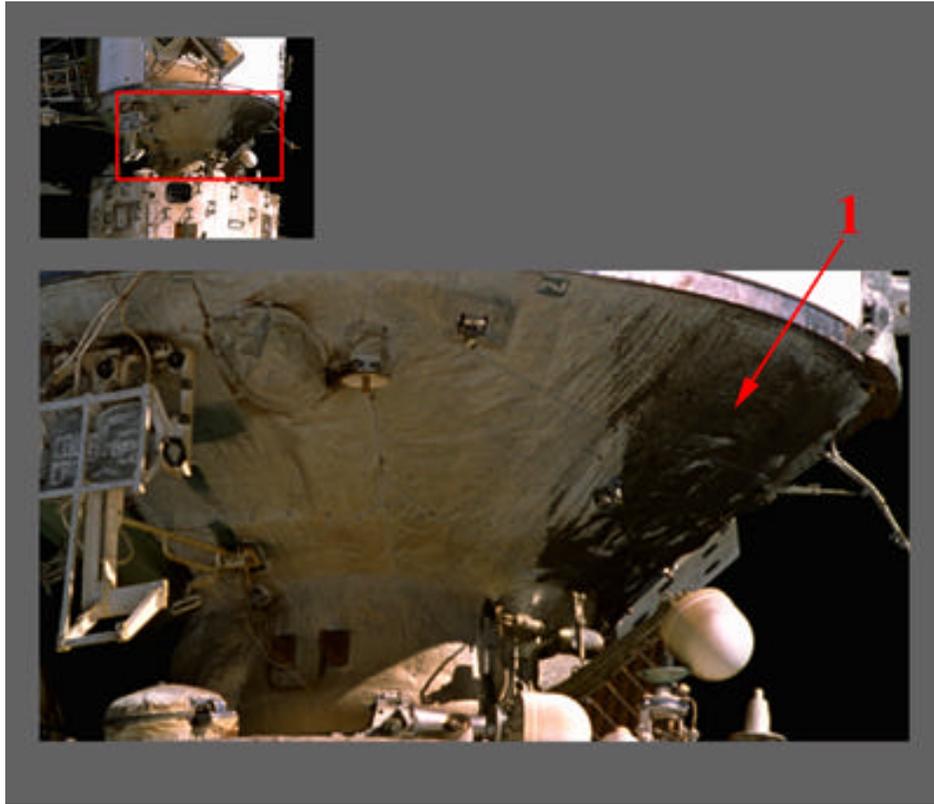
**Figure 3.14 Deposition on +ZB Kvant End Dome**

Figure 3.14 is the highest resolution photograph to date of the +ZB side of the Kvant end dome. There is dark deposition [1] covering approximately 25 percent of the +ZB side of the end dome facing the +YB direction, while the rest of the end dome appears to have little deposition or discoloration. There is a similar dark deposition covering approximately 50 percent of the -ZB side of the end dome facing the +YB direction. The deposition on each of these sides appears to be caused by the same source, due to the similar appearances and close proximity of the depositions around the circumference of the end dome. Approximately 40 percent of the periphery of the end dome shows deposition.

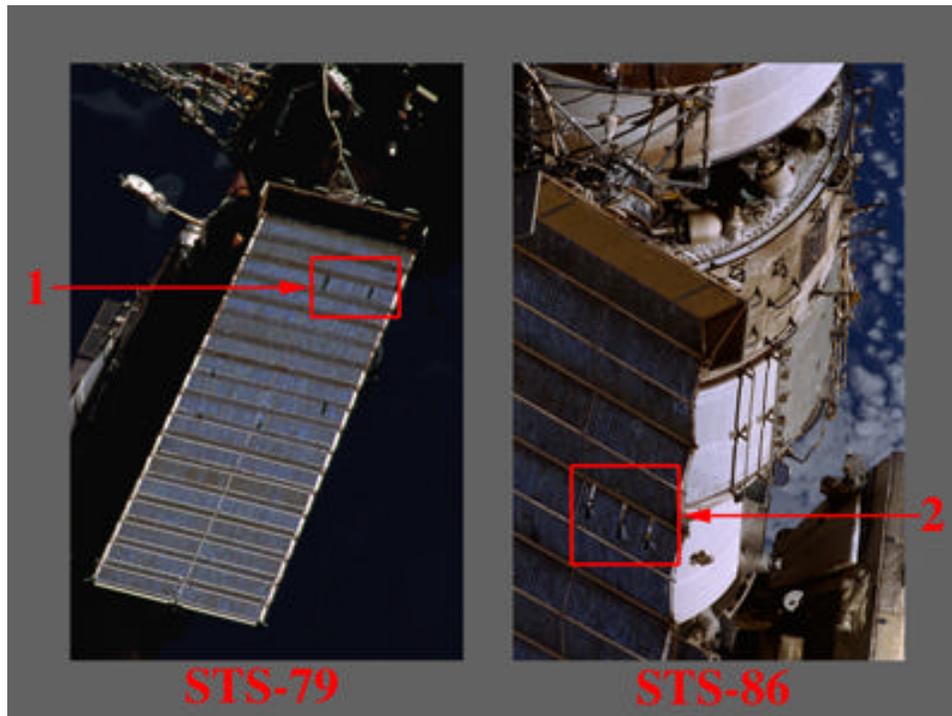
**Figure 3.15 Solar Cells Detaching from Kvant SP#1**

Figure 3.15 is a comparison of photographs taken on STS-79 and STS-86 which both show strips of solar cells detaching from the wire frame of Kvant SP#1. The photograph on the left shows two strips of solar cells lifted off the support frame of the array [1], while the photograph on the right shows that a third strip of solar cells, in the middle of the first two, is also lifted off the support frame [2]. Other strips of solar cells were first observed lifted off the support frame of the array on STS-71, and this type of anomaly has not been seen on other Mir arrays.

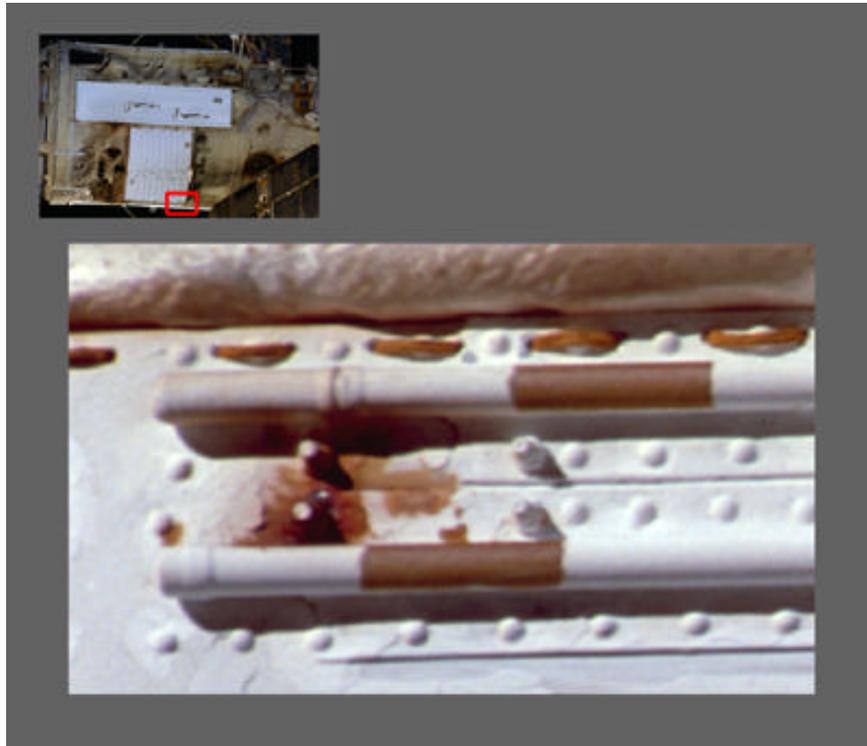
**Figure 3.16 Possible Leak on Spektr Radiator**

Figure 3.16 is the highest resolution photograph to date of a possible leak around bolts and rivets on the +XB, -YB corner of the Spektr radiator. A possible leak was previously identified on the +YB side of the radiator. (Reference 6.) This leak on the +XB, -YB corner was visible on all missions where this radiator was facing the Shuttle, however, the lower resolution of previous mission imagery does not allow for a comparison of leak size to determine if the leak has grown. From this image, the size of the stain left by the leak was determined to be approximately 9 cm<sup>2</sup>. The dark areas on top of the tubing are hold-down brackets and are not part of the leak.

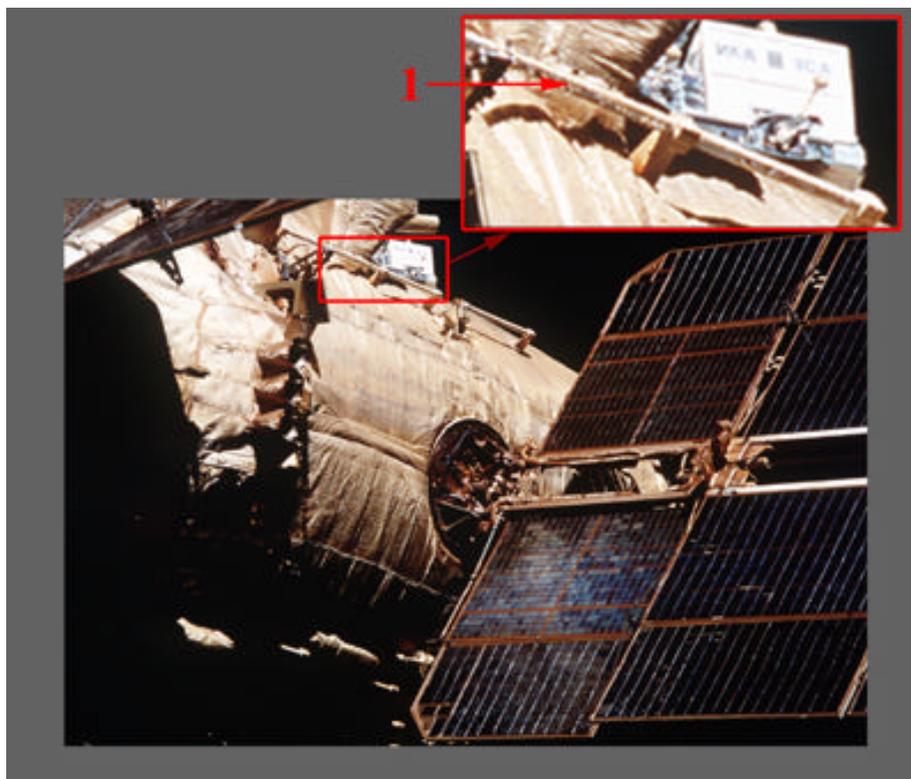
**Figure 3.17 Chipped Paint on -XB, -ZB Handrails of Spektr**

Figure 3.17 is the first photograph identified which shows chipped paint on Spektr handrails [1]. Spektr docked with Mir in June, 1995, therefore this paint has begun to chip or peel within the first 28 months of the module's deployment.

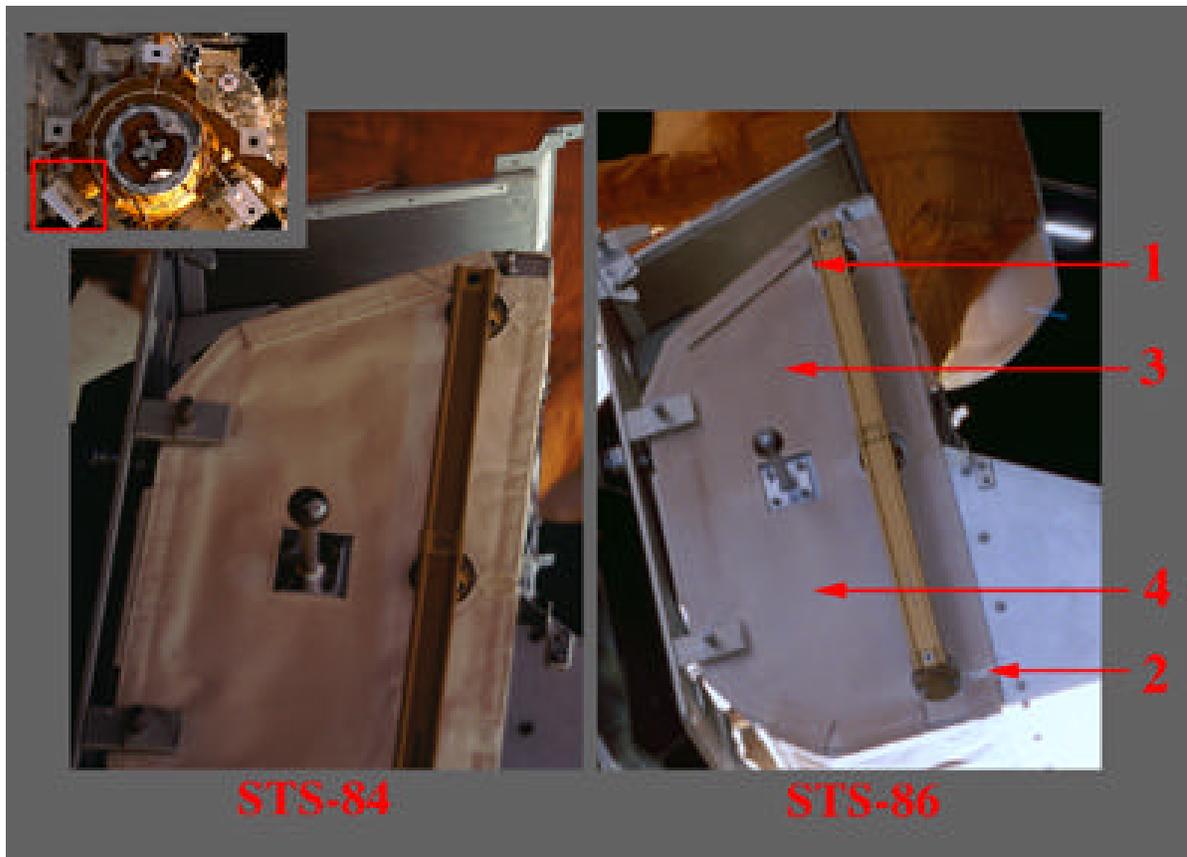
**Figure 3.18 Deposition on +XB Surface of OPM Thermal Blanket**

Figure 3.18 is a comparison of photographs of the OPM between STS-84 and STS-86. The OPM was deployed on the Docking Module during an EVA on April 29, 1997. The image on the left, taken in May 1997 during STS-84, reveals a highly preferential pattern of discoloration on a thermal blanket covering the end of the OPM facing the +XB direction. The image on the right, taken on STS-86 approximately 4 months later, indicates that the discoloration is now more uniform across the surface of the thermal blanket. However, there are areas to the left of the handrail attach points that appear to be receiving little deposition [1]. These handrail supports protruding from the surface appear to block the deposition which is striking the rest of the thermal blanket, creating a “shadow” of the supports to the left of the actual supports. In addition, there is a small flap of thermal blanket, stitched back along a seam to the right of the lowest handrail attach point, which appears to be receiving less deposition than the thermal blanket adjacent to it [2]. This flap may be shielded by areas of thermal blanket adjacent to it which protrude higher off the surface of the experiment carrier. In general, the discoloration on the +ZB half of the experiment appears darker brown in color than the -ZB half [3 & 4 respectively].

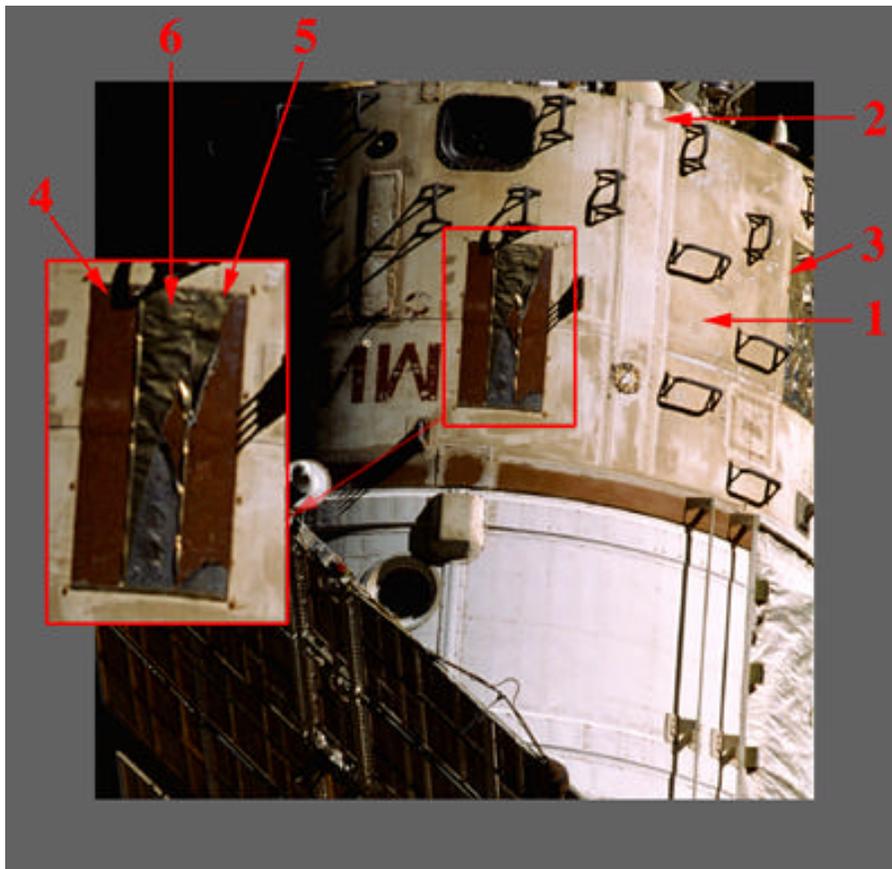
**Figure 3.19 +ZB Discoloration and Damage on Base Block**

Figure 3.19 is the highest resolution photograph to date of the +ZB side of the Base Block. This image verifies that the pattern of general discoloration and damage seen on the surface of the Base Block is uniform around the circumference of the module. There are areas of non-preferential discoloration [1], and areas of preferential discoloration [2] which appear to follow along the seams of the module surface. Two of the four micrometeoroid impact sensors mounted around the circumference of the Base Block can be seen in this photograph. Damage on one of these sensors [3] was reported previously in the STS-63 report. Looking at the enlarged inset of the other sensor, this photograph provides new details on the condition of the sensor. The top layer of one of the outer panels appears to be missing completely [4], leaving the possible middle layer which appears red in color. Approximately 25% of the top layer of the other outer panel [5] and 50% of the inner panel [6] remains intact. Approximately 65% of the middle layer and 10% of the bottom layer of the outer panel [5] is visible, while approximately 20% of the middle layer and 30% of the bottom layer of the inner panel [6] is visible. Compared to the damage on the other sensor [3] which was reported previously, the damage on the highlighted sensor appears more uniform.

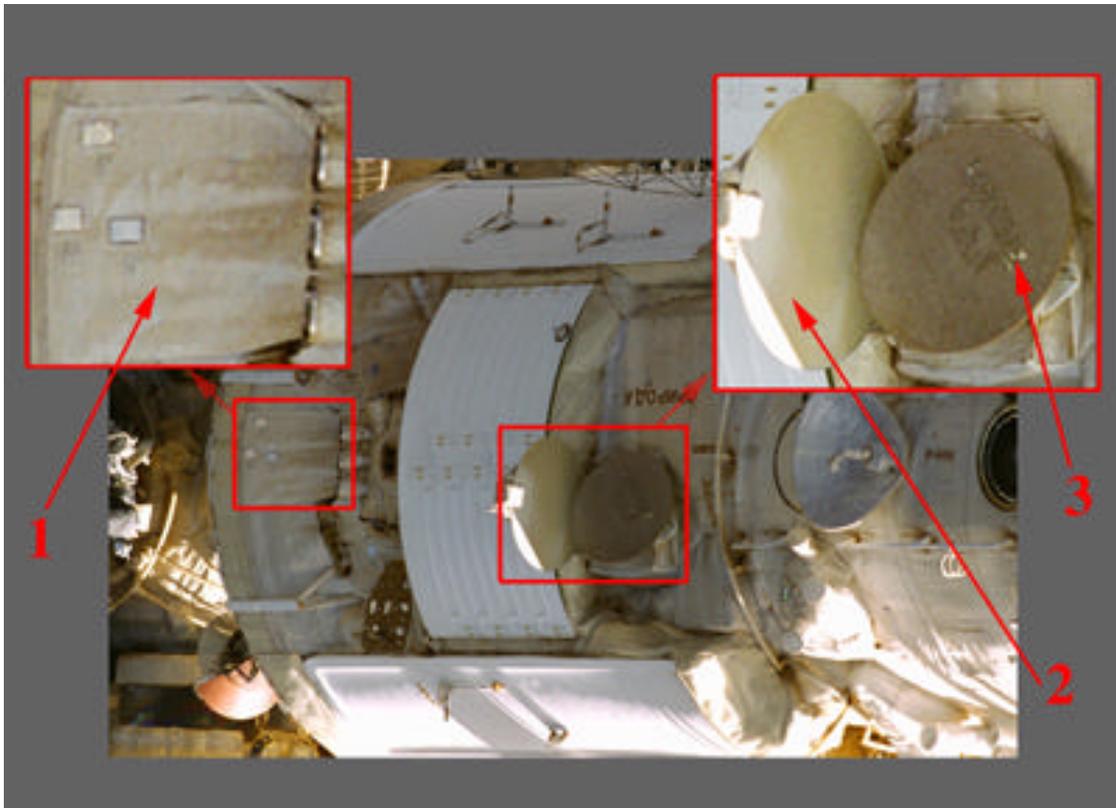
**Figure 3.20 -XB Deposition and Damage on Priroda**

Figure 3.20 is the highest resolution photograph to date of the -XB side of Priroda. Deposition [1] is visible on the thermal insulation directly below three attitude control thruster nozzles. This deposition is similar to deposition previously noted around thruster nozzles on other modules such as Kvant-2 and Spektr. There are also a couple of anomalies on the surfaces of the Delta-2P Radiometer [2]. The radiometer dish, which is extended perpendicular to the surface of Priroda, has some discoloration which appears preferential-oriented. Two regions of the dish do not appear as discolored as the rest of the dish. If the discoloration is caused by the deposition of some contaminant on the dish, objects surrounding it may be shadowing areas so that they receive less deposition. The radiometer dish, which is mounted flat against Priroda, appears to have some surface damage. The texture pattern just off the center of the dish suggests that the outer covering of the dish may be peeling off the surface [3].

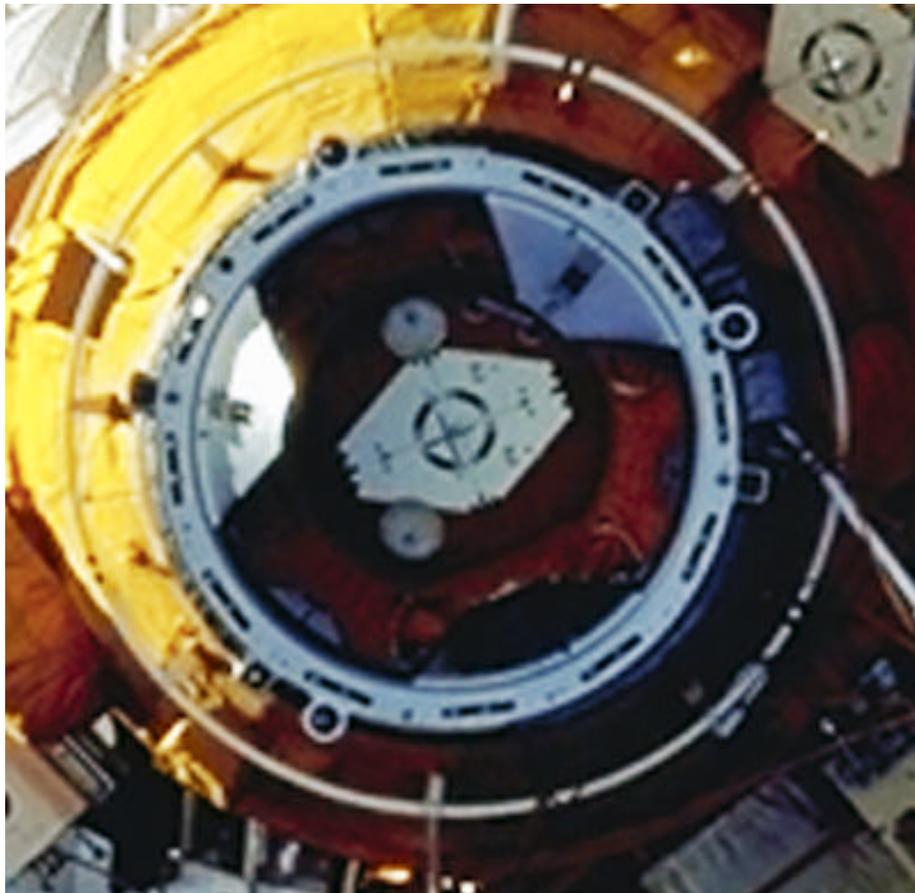
**Figure 4.1 Photo of Docking Mechanism during Approach**

Docking occurred during a night pass on STS-86. The video imagery obtained with the Orbiter Docking System (ODS) centerline camera during approach showed the centerline docking target to be in good condition. However, there were significant reflections in the video when the docking latches were in the field-of-view. The video imagery was not suitable for assessment of the docking latches, alignment guides, electrical connectors, or retroreflectors. However, a view taken with the 70 mm camera and telephoto lens during approach (prior to darkness) was sufficient to show the capture and structural latches were in proper position and the centerline and non-axial targets were in good condition. The retroreflectors and electrical connectors appear to be in good physical condition. However, the imagery was not of sufficient resolution to detect discolorations that might exist. The image is shown in Figure 4.1.

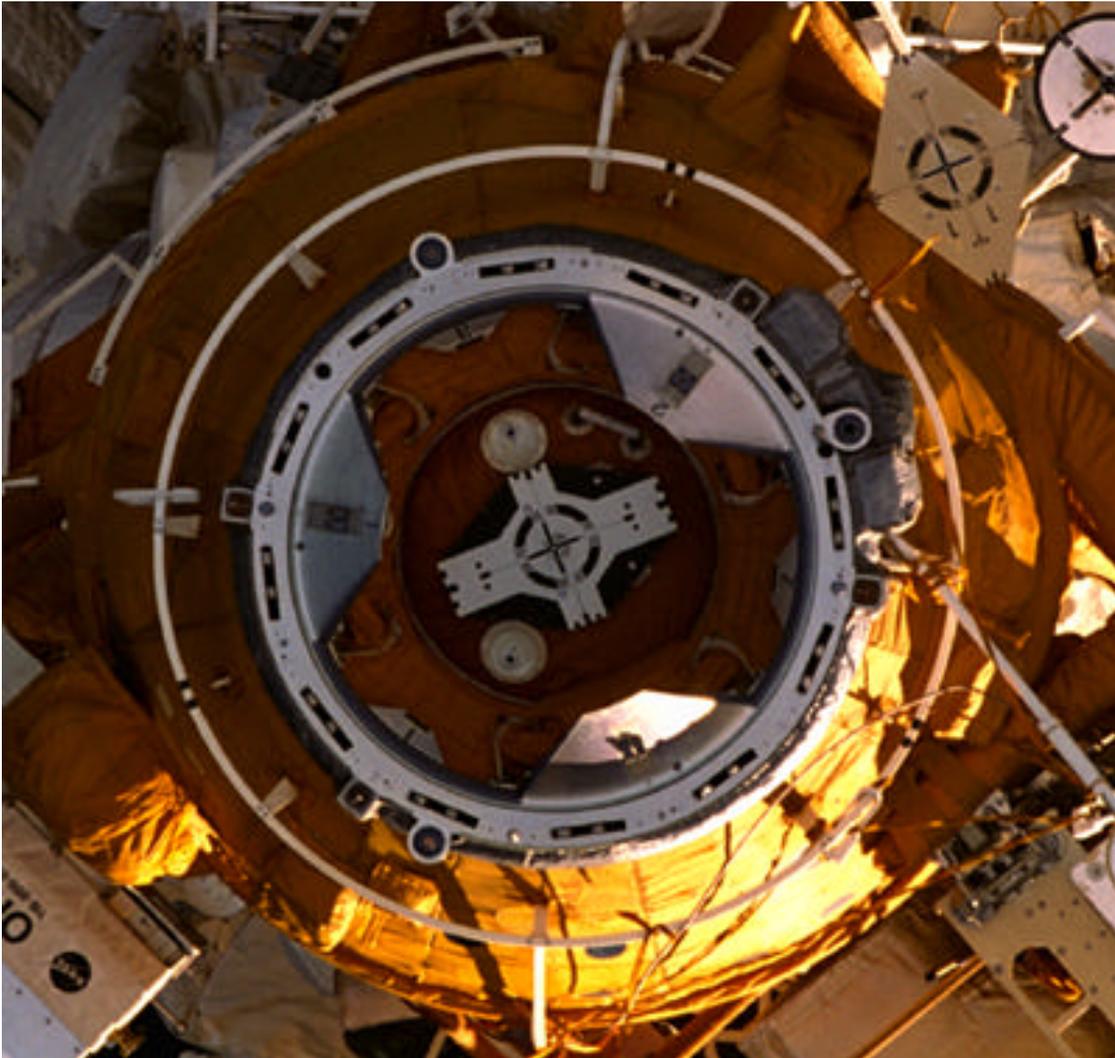
**Figure 4.2** Photo of Docking Mechanism during Backaway

Undocking and backaway also occurred during a night pass. A new centerline docking target was installed during STS-86. The video imagery obtained with the ODS Centerline camera during backaway showed the newly-installed centerline docking target to be in good condition. As during the docking, reflections prohibited use of the video imagery for assessment of the docking latches, alignment guides, electrical connectors, or retroreflectors. However, a view taken with the 35 mm camera and telephoto lens during backaway (after sunrise) was sufficient to show the capture and structural latches were in proper position and the centerline and non-axial targets were in good condition. The photographic image is shown in Figure 4.2.

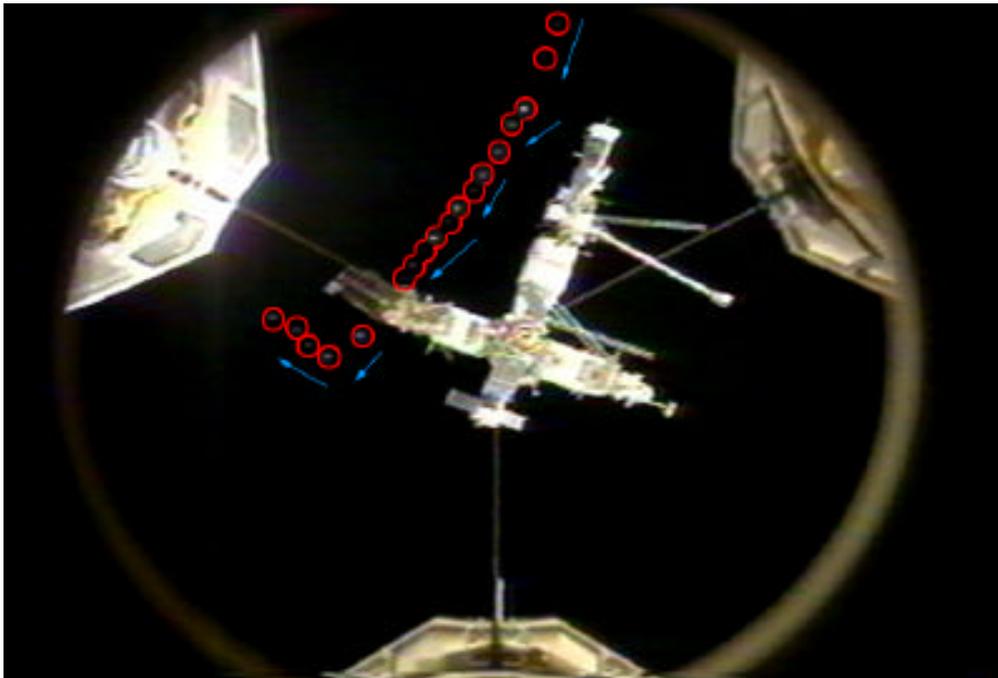
**Figure 6.1 Debris Observed Prior to Docking at GMT 270d:19h:17m:08s**

The ODS centerline television camera did not show any debris during the time of docking. However, it did detect debris prior to docking. The first piece of debris was noted moving away from the Payload Bay (PLB) approximately 52 minutes prior to soft dock. Another piece was captured by the centerline camera approximately 44 minutes prior to docking, as it traveled in front of Mir and changed direction abruptly by approximately 90 degrees, probably due to thruster firings. This debris and its trajectory are illustrated in Figure 6.1. Other pieces of debris were noted in the area surrounding the ODS approximately 27 minutes prior to soft dock. One piece of debris, recorded by camera D approximately 19 minutes prior to docking, appears to come into the ODS from the direction of Mir and may have made contact with the Orbiter, as shown in Figure 6.2. However, contact was not observed and none of the other pieces of debris observed prior to docking were seen to make contact with Shuttle or Mir hardware.

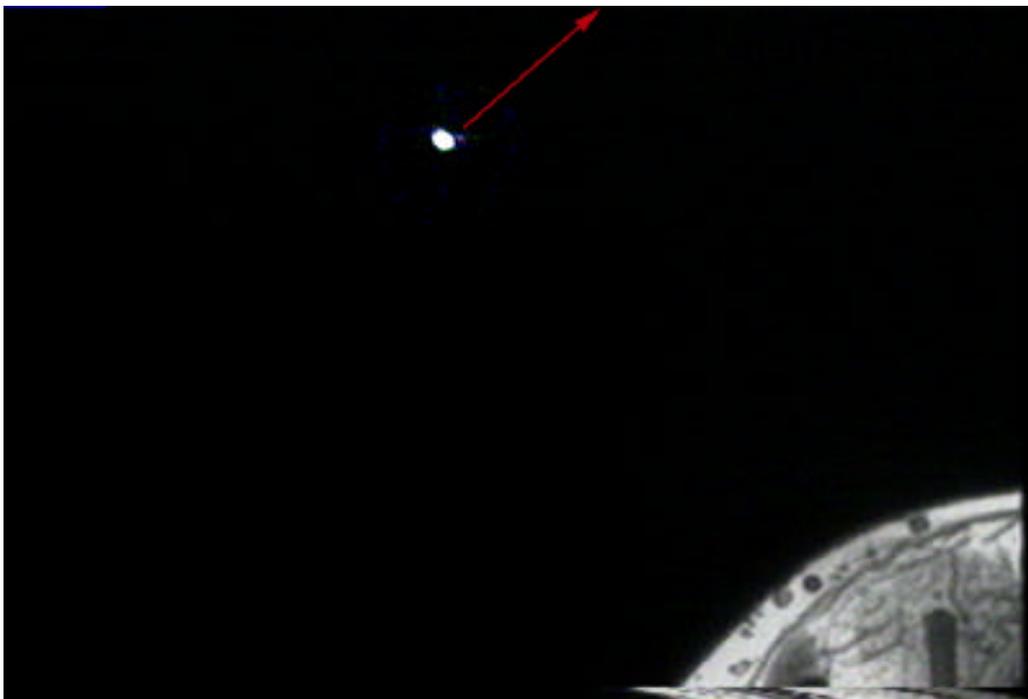
**Figure 6.3 Debris after Undock at GMT 276d:17h:46m:53s**

During the 20 minutes following undocking, numerous pieces of debris were noted. Figure 6.3 shows a view from camera B and a large piece of debris passing over the PLB. A few pieces were noted passing between the Shuttle and Mir 40-60 minutes after undock. Most of the debris noted during this phase are barely visible.

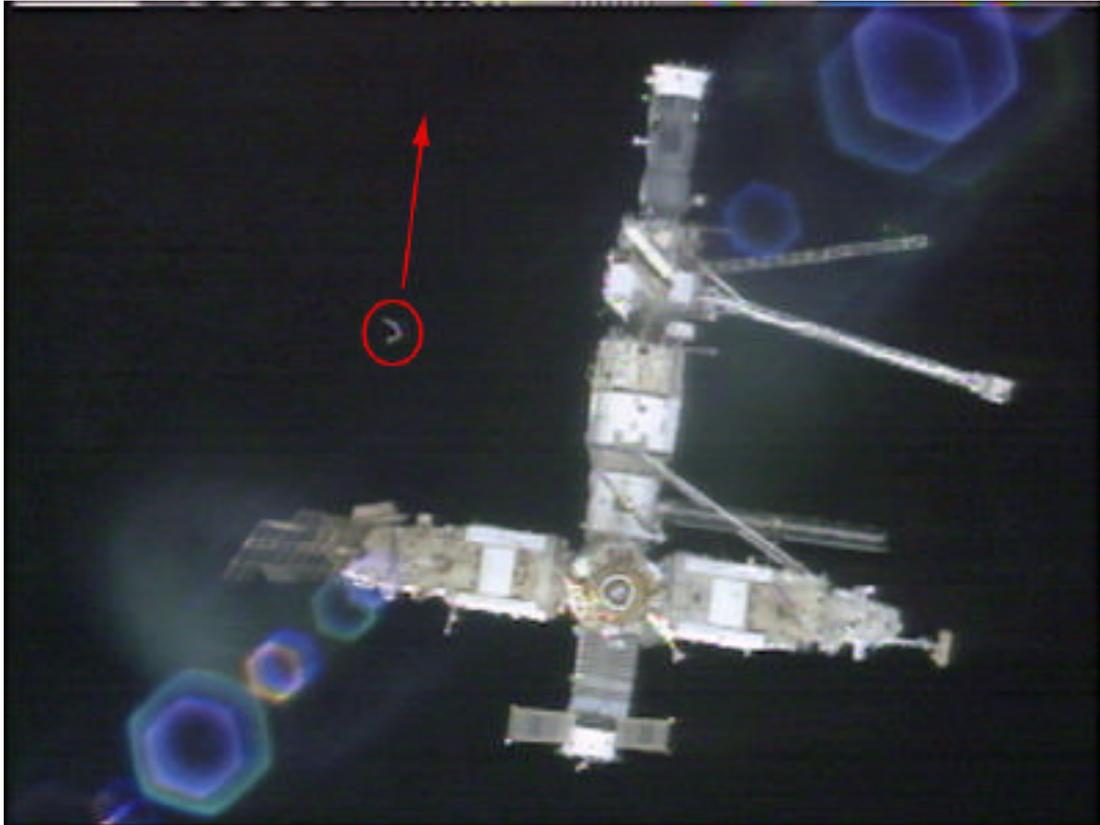
**Figure 6.4 Rope-like Debris noted during Station-keeping at GMT  
276d:18h:11m:28s**

Several pieces of debris were noted during station-keeping. Among these is the rope-like debris illustrated by the camera D video still frame shown in Figure 6.4. This debris moved parallel to the XB axis of Mir 48 minutes after undock. Other debris was noted passing either behind or in front of Mir.
